Manhole Inspection Summary

Manhole # S25A__007MH

Insp Date: **8/20/07 8:43 AM**

Location Address: **1213 EDMONDSON AVE**

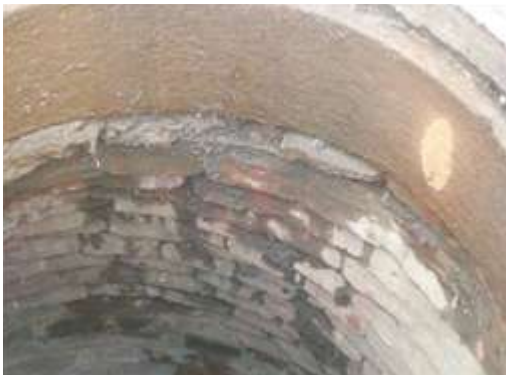
Defect 2

Condition: ☐ Sound ☐ Cracked ☐ Root Intrusion ☐ Loose Brick ☒ **Deteriorated**

Infiltration: ☐ None ☐ Joint ☐ Cracks ☐ Mortar ☐ Roots ☒ **Wall**

DETERIORATION AND INFILTRATION
OF CHIMNEY

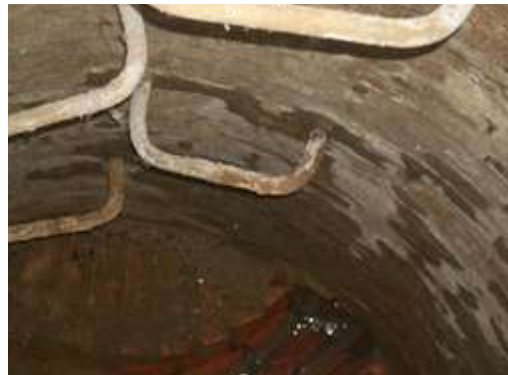
Defect 3

Infiltration: ☐ None ☐ Joint ☐ Cracks ☐ Mortar ☐ Roots ☒ **Wall**

Count: **4** Missing: **0** ☒ **Corroded**

CORRODED STEPS AND BARREL
INFILTRATION

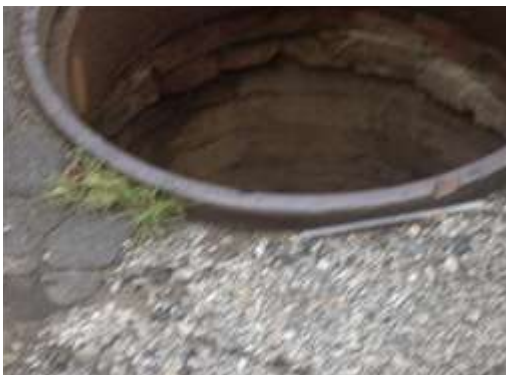
Defect 1

Diameter: **24** (in.) Length: (in.) Dist A/B Grade: **1** (in.)

GRADE ADJ 1"

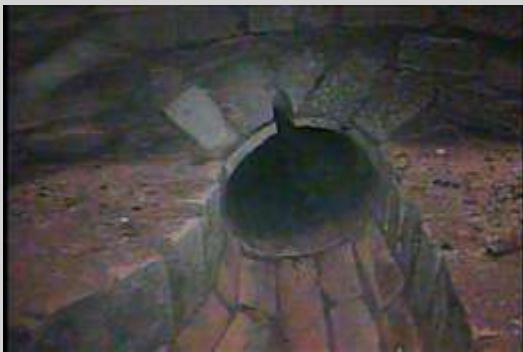
12 O'Clock Outflow

8 in. Circular Gravity Sewer
Pipe Out @ 12 O'Clock

Pipe Height: **7.2** (in.) Rod and Bar (Angled)
Pipe Material: **Clay** ☐ Pipe Lined
Invert Depth: **8.91** (ft.) Flow Characteristics: **Slow**
Deposits: ☒ None ☐ Mud ☐ Sludge ☐ Debris ☐ Grease
Silt Depth: (in.) Deposits Extent:
Infiltration: **None** Pipe Seal Cond: **Broken**

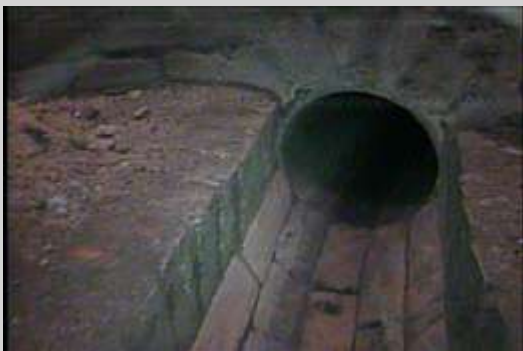
7 O'Clock Inflow

8 in. Circular Gravity Sewer
Pipe In @ 7 O'Clock

Pipe Height: **7.2** (in.) Rod and Bar (Angled)
Pipe Material: **Clay** ☐ Pipe Lined
Invert Depth: **8.87** (ft.) Flow Characteristics: **Slow**
Deposits: ☒ None ☐ Mud ☐ Sludge ☐ Debris ☐ Grease
Silt Depth: (in.) Deposits Extent:
Infiltration: **None** Pipe Seal Cond: **Sound**

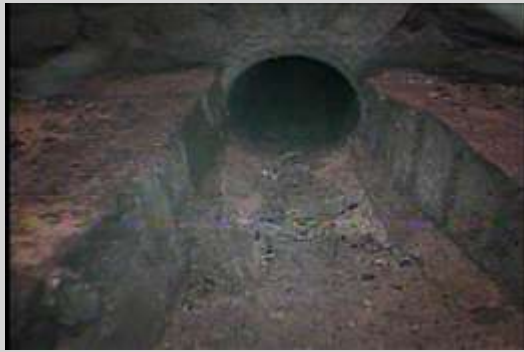
9 O'Clock Inflow

6 in. Circular Gravity Sewer

Pipe In @ 9 O'Clock

Pipe Seal Cond: **Sound**
